August 7, 1969  
M & R No. 39675

EVALUATION TESTS OF  
"DEFIANT SELF RECTIFYING SAFETY STEEL POST"  
MANUFACTURED BY DEFIANT INTERNATIONAL, INC.

69-11

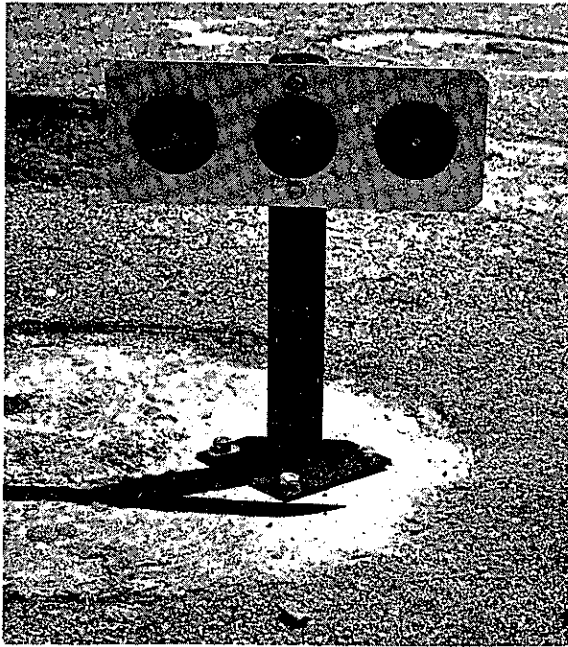
FIGURE 1

Two models of the Defiant Safety Post were tested. They were identically constructed differing only in the over-all height of the post which was 18 in. and 48 in. (Figures 1 and 2). A standard 30 in. height is also available. The manufacturer also indicated they can adapt this same principle to a wide range of heights and sizes.

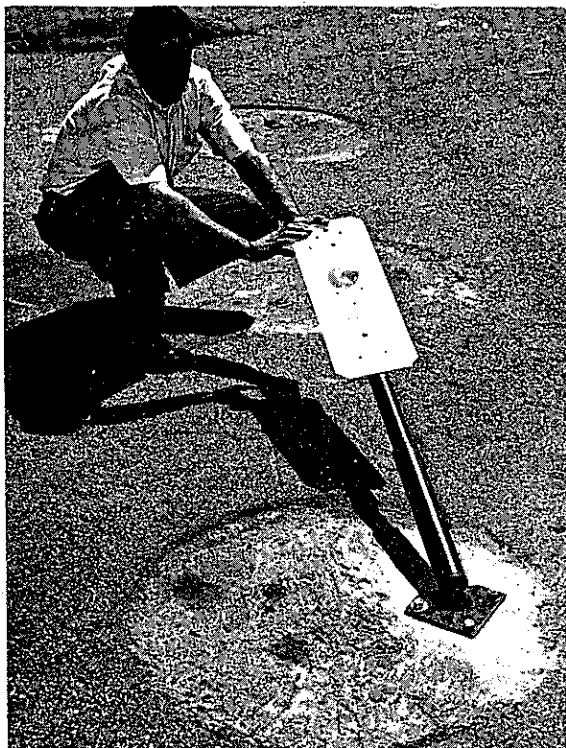
FIGURE 3

The functional part of this device consists of a 2-in. dia. steel pipe post secured to a semi-triangular  $\frac{1}{4}$ " thick steel base plate by a strong coil spring. The spring is attached to a hook welded to the base plate at one end and to a steel plug welded inside the post, approximately 12-in. up from the base plate, at the other. The principle is that when force is applied to the post the spring stretches allowing the post to lay over. When the force is removed the tensioned spring restores the post to the upright position (Figures 3 and 4).

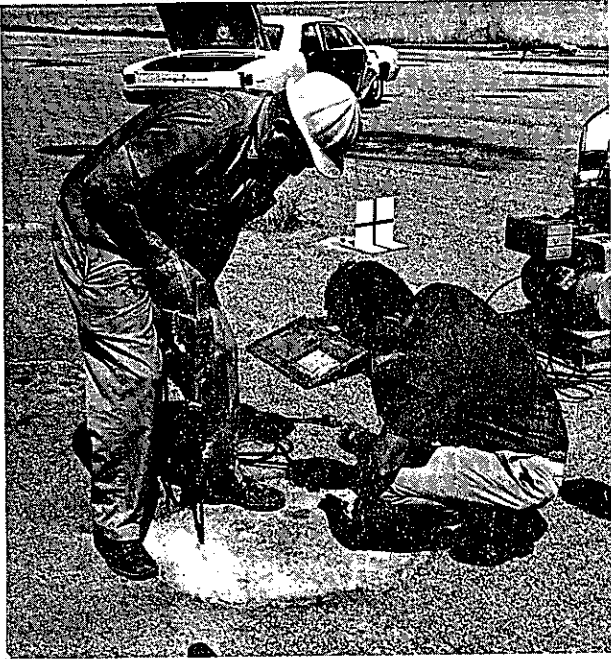
FIGURE 5

The units tested were installed on the day of the test at our Lincoln airport test facility. The base was bolted down to an existing concrete footing with  $\frac{1}{2}$ " diameter "red head" bolt studs (Figures 5 and 6). The same studs were utilized for all impact tests on both units.
